River Wensum

Restoration Strategy

Issue 13, February 2014

Sculthorpe Moor Restoration Scheme

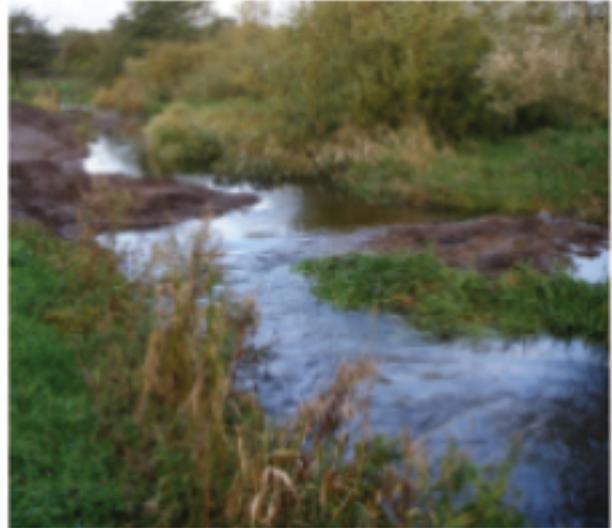
Image: Redistribution of existing gravel bed and re-profiling of spoil banks creates a narrower, more sinuous river course

A sustainable solution to improve a silted gravel bed is to squeeze the flow using berms, woody debris or pinned willow. This constricts the over-wide channel, increasing water velocity and keeping silt and sand on the move so that the gravel bed remains exposed. This should provide ideal spawning habitat for trout and home to an assortment of invertebrates and aquatic plants that depend on a clean gravel substrate.

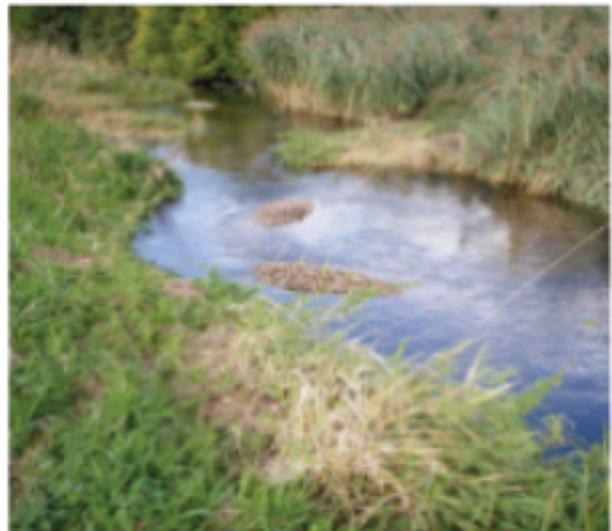
Image: Newly installed gravel glide, resulting in varying river bed height and flow diversity

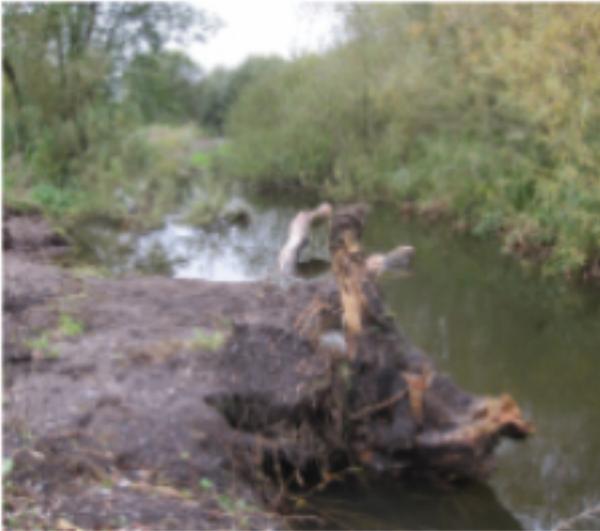
Image: Locally available woody debris has been installed to increase habitat and flow diversity

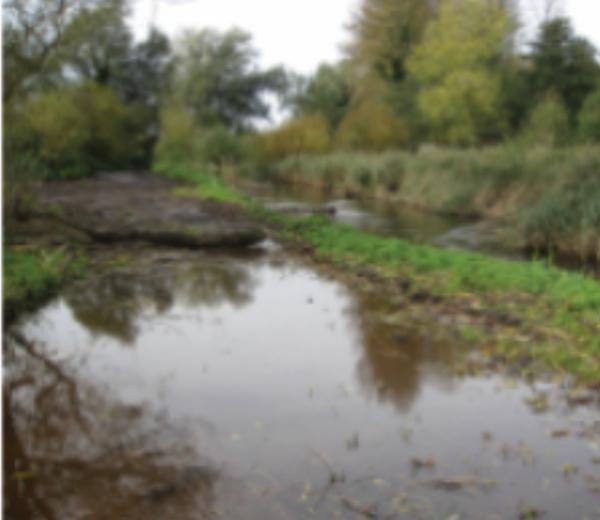
Image: Removal of spoil embankments at selected locations has restored the connection between river and floodplain during high flows

Large spoil embankments, a remnant of past dredging activities, occur along much of the reach. These have been selectively removed on the southern bank, to improve floodplain connectivity. The result, floodplain wetting during periods of high flow, provides multiple benefits. Floodplain biodiversity is improved, sediment is removed from the channel and flood risk to people and property in Fakenham and further downstream is reduced.

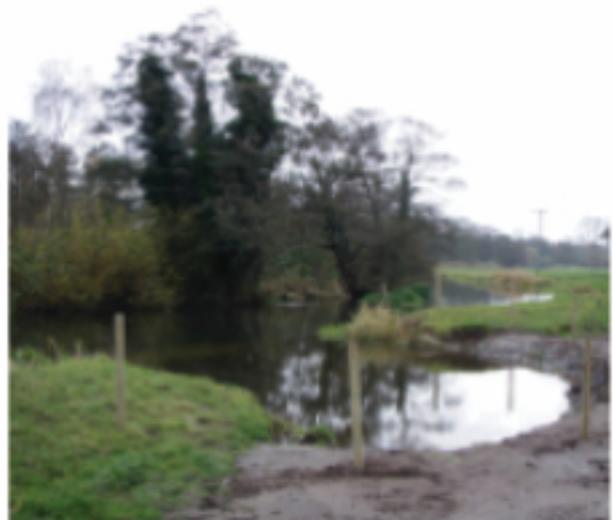
Image: Enhanced fish refuge at Costessey

This opportunity was too good to miss. Working with the landowner, we developed a simple low cost solution which enlarged the refuge feature and addressed the landowner’s concern of repeated inundation of the marshes during prolonged periods of wet weather.

The scheme has been successfully implemented by Stephen Lown and Andy Woods from the North Norfolk Operations Field Team. As a finishing touch, alder trees will be planted to provide some shade and restrict vegetation encroachment. This is a reason why this type of habitat is rare, because without continued maintenance the functionality of fry bays gradually reduces. We will assess the need for any light touch vegetation clearance when planning any future maintenance or restoration work within the reach.

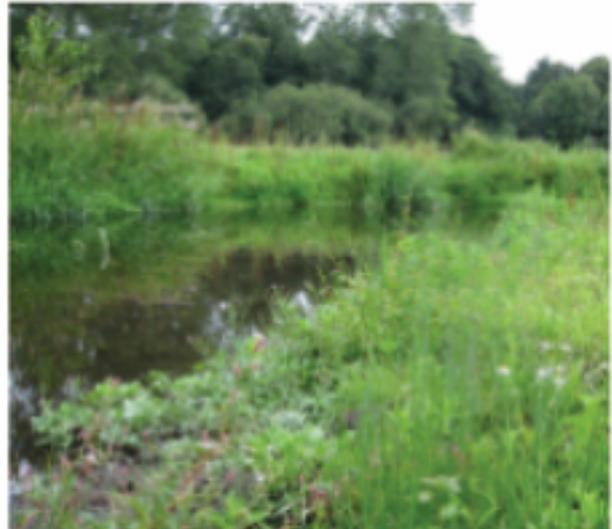
Image: Ryburgh End scheme (August 2013) - diverse range of flora establishing on berms

The low level shelves that we created at summer water level at the channel margins have been colonised by a diverse flora including water mint, water forget-me-not, brooklime and gipsywort. The river channel itself supports a number of typical chalk stream plant species including watercress, water starwort, lesser water-parsnip and whorl-grass.
